BEHAVIOR OF THREE-SPAN CONTINUOUS PRE-STRESSED CONCRETE
GIRDER FOR PRECAST CONSTRUCTION OF MONORAIL TRANSIT SYSTEM

A Thesis Submitted to the Graduate School of Naresuan University
in Partial Fulfillment of the Requirements
for the Doctor of Philosophy in Civil Engineering

2021

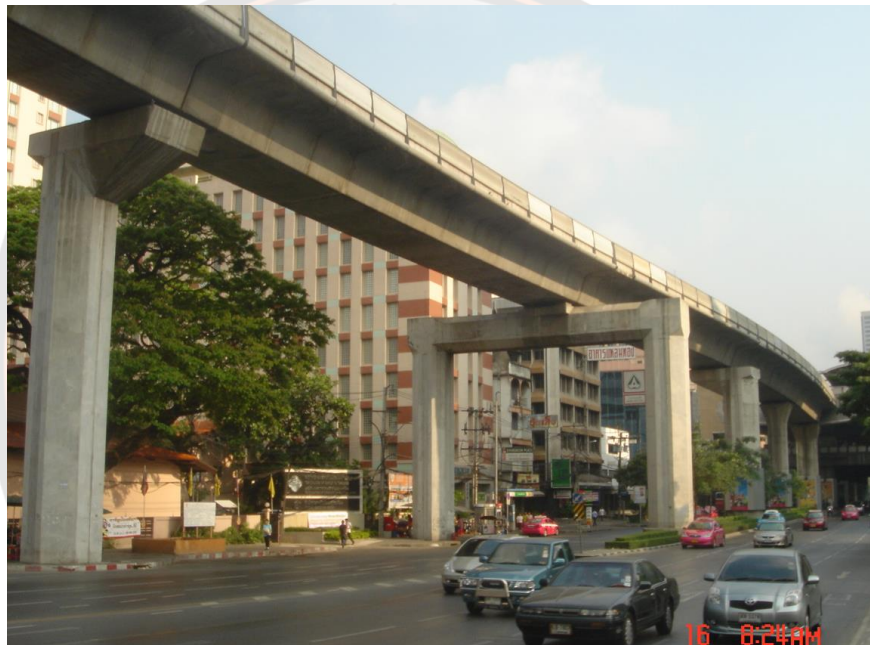
Figure 1 Box girder bridge for BTS sky train in Bangkok, Thailand.

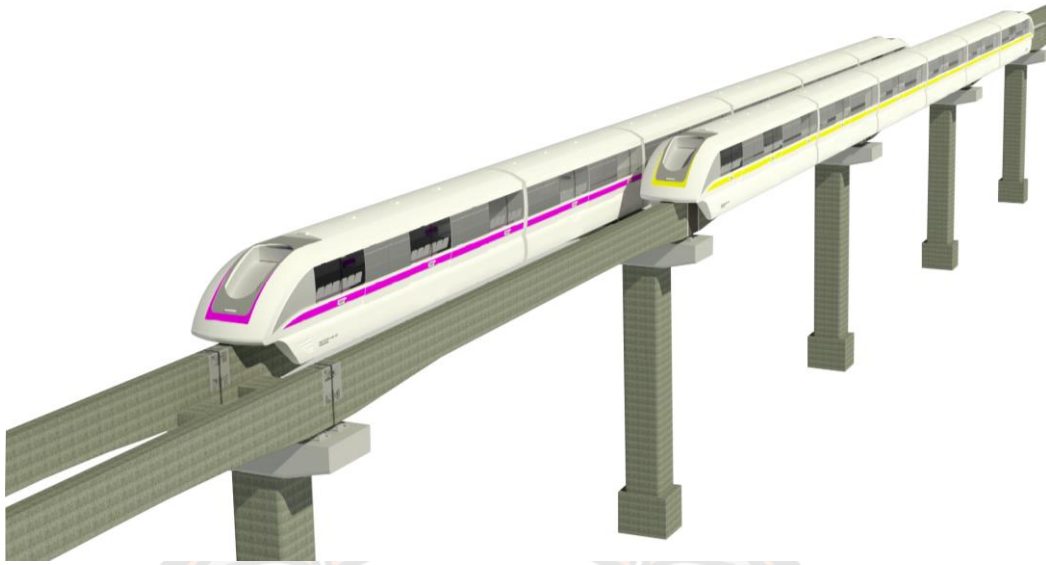
Figure 2 Typical display of Pink line and Yellow line monorail transit systems [29].

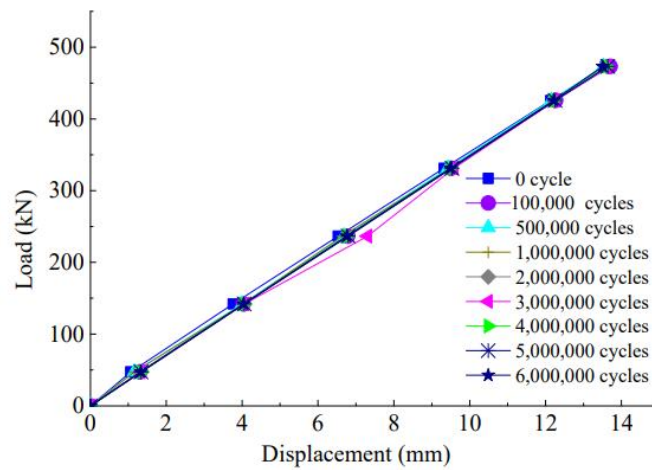
Figure 15 Static load-displacement curve at mid-span [22]

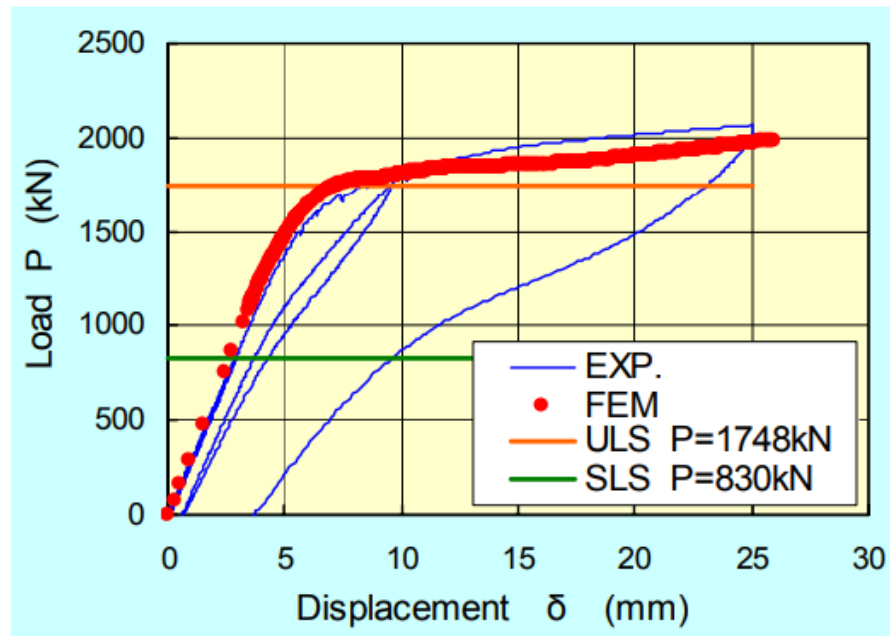
Figure 20 Comparison of experimental and FEM analysis [31]

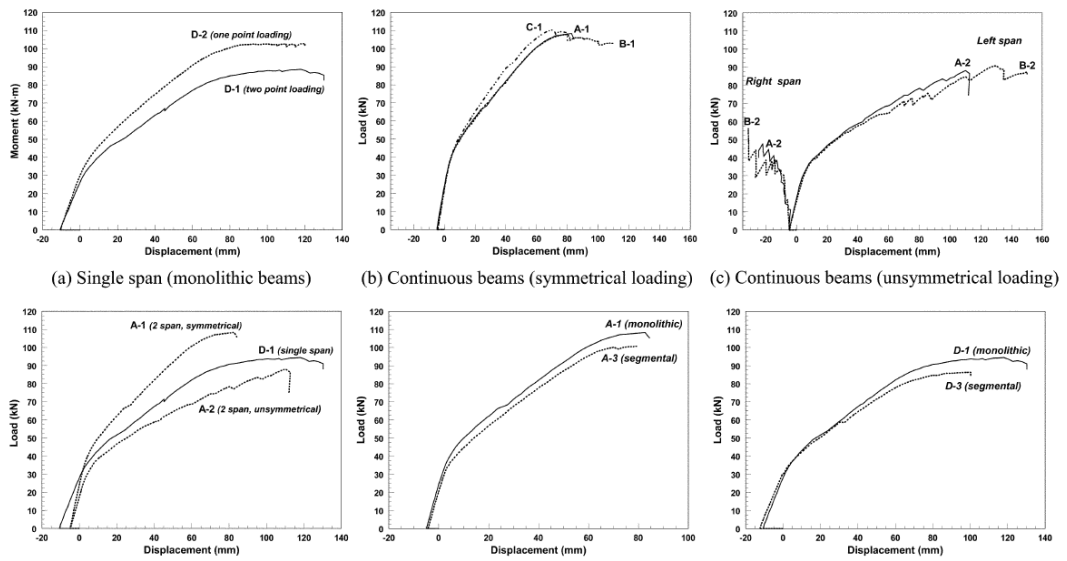
Figure 26 Load-displacement characteristics [33]

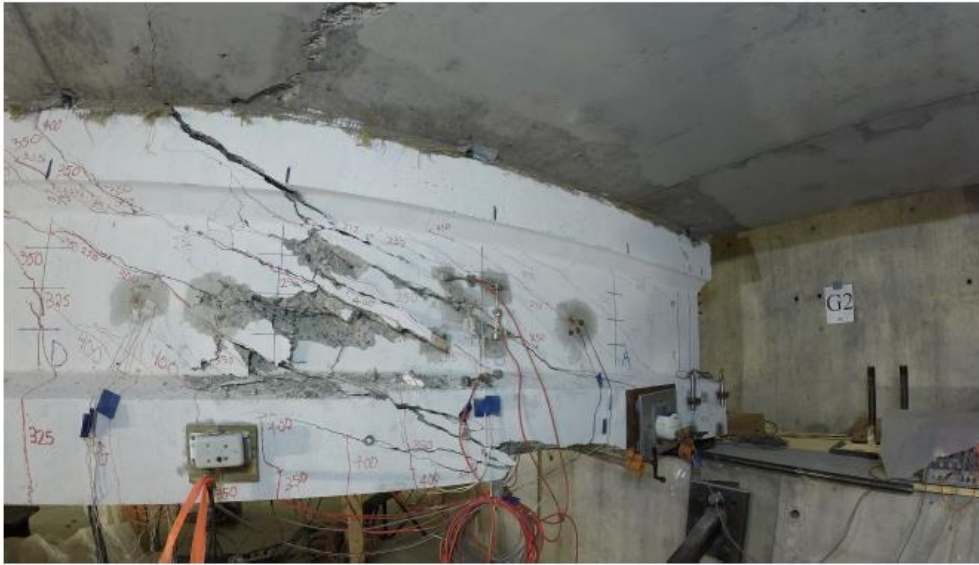
Figure 44 Web shear crushing and deck punching in G2 during LBUE looking north [35]

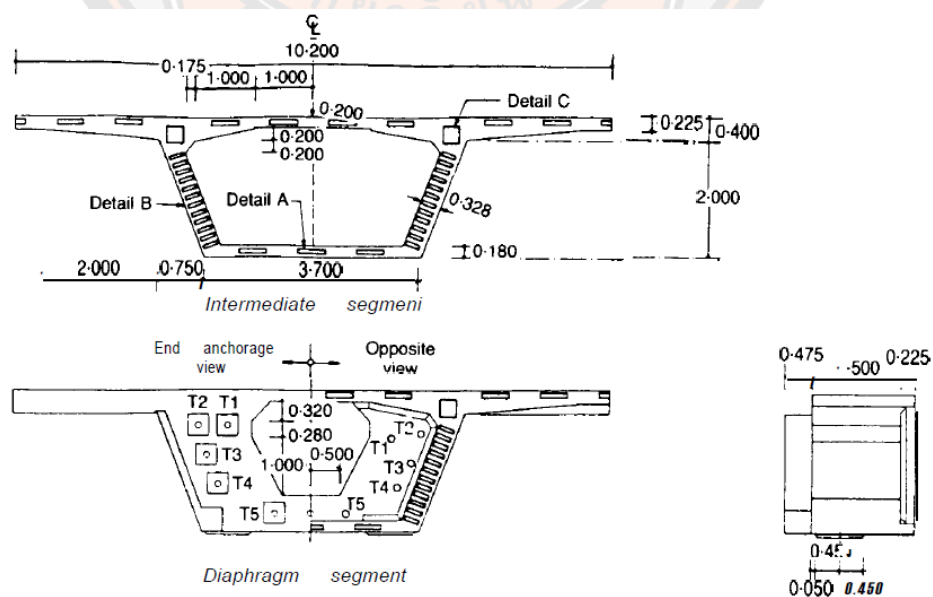
Figure 55 Details of segments [38]

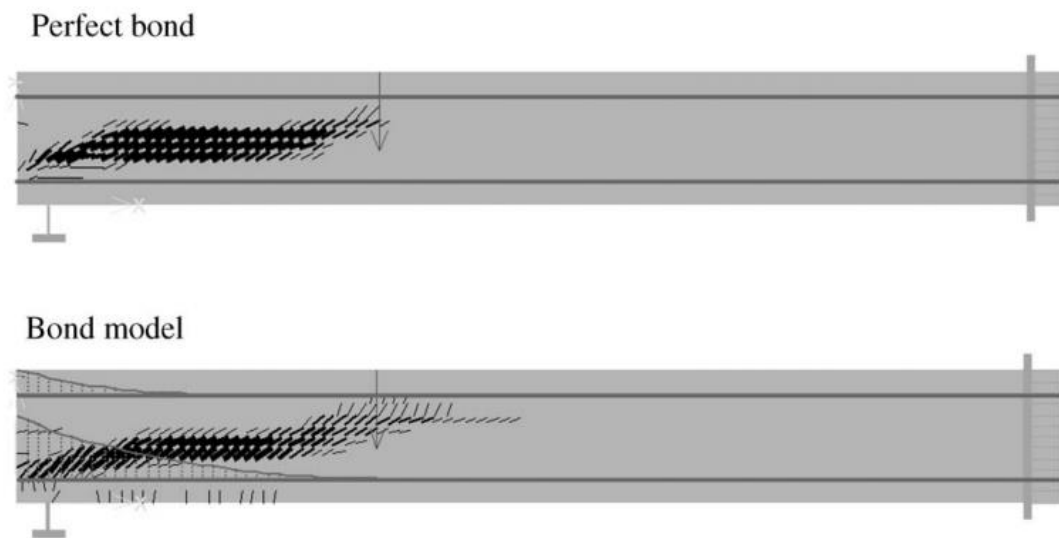
Figure 68 Cracks patterns observed in finite element analysis [40]

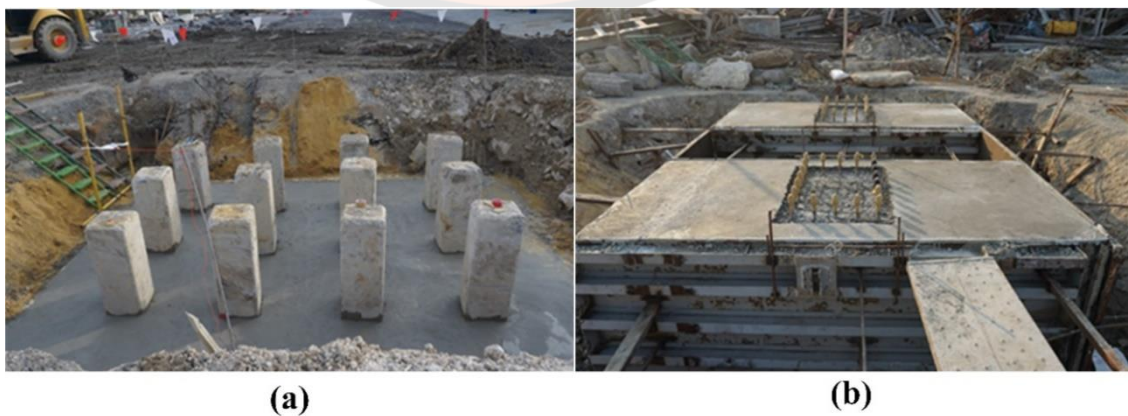
Figure 87 Construction details of the foundations (a) pre-cast piles foundation, and (b) pile caps.

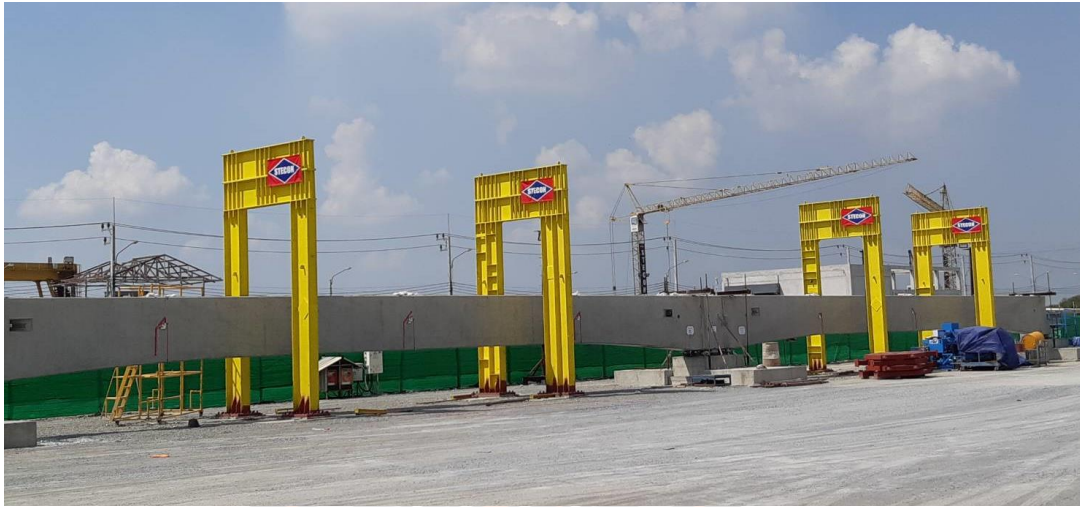
Figure 88 Typical view of the FPPC monorail bridge girder.

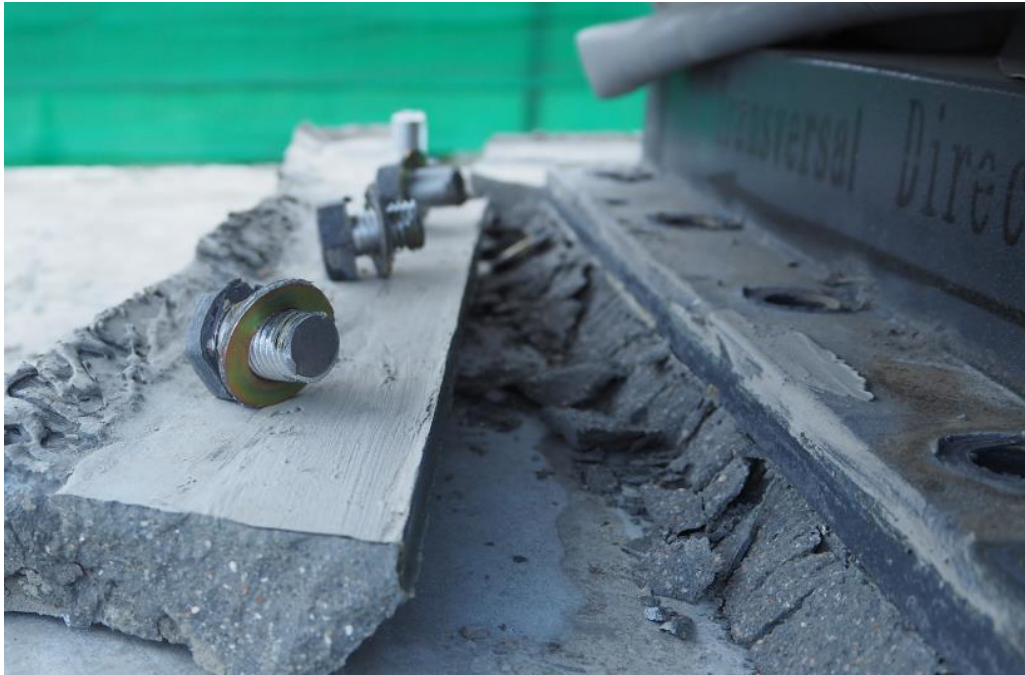
Figure 162 Ultimate failure of bearing B-01.

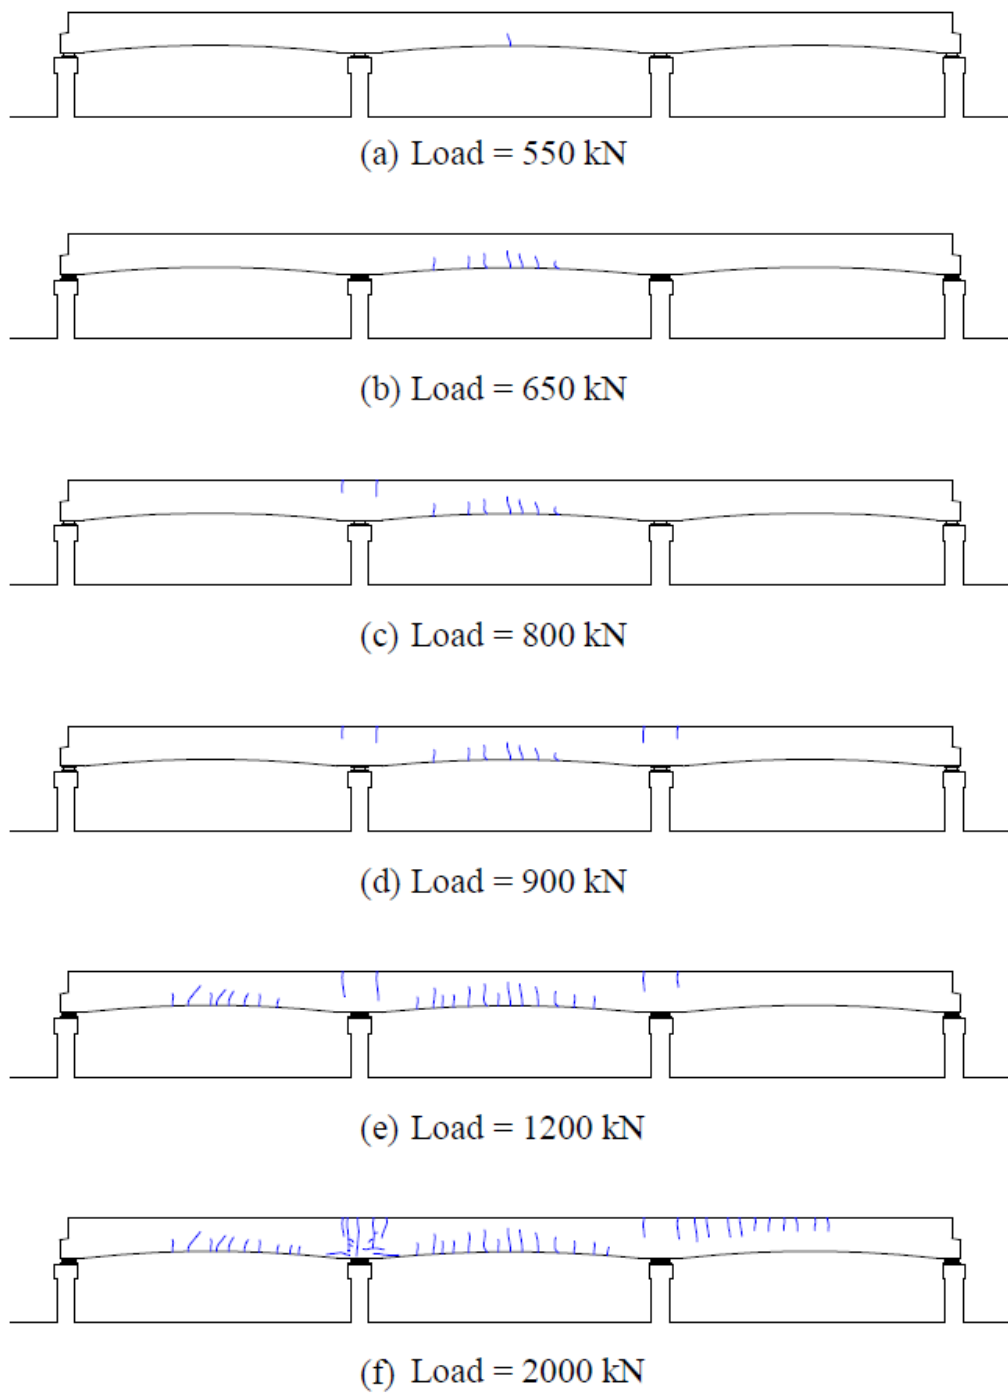
Figure 163 Cracking pattern of the FPPC girder at different loads, a) 550 kN, b) 650 kN, c) 800 kN, d) 900 kN, e) 1200 kN, and f) 2000 kN

Meanwhile, the first crack at the top side of the right span was observed at an ultimate load of 2000 kN (Fig. 163 (f)). However, the bottom side of the right exterior span remained uncracked. At the ultimate state, very wide cracks were observed at the wet joints and middle span. Also, the severe splitting and crushing of the concrete was observed near support S-2, as shown in Figs. 164 and 165.

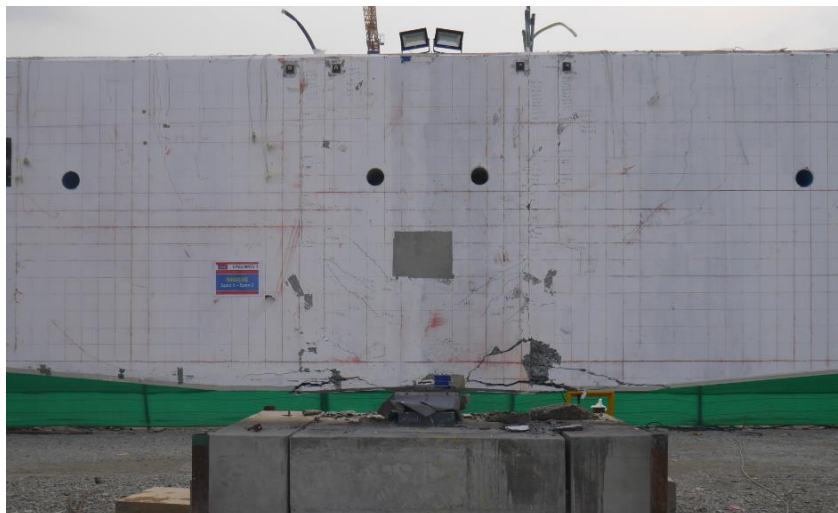
Figure 164 Cracking pattern at the pier segment.

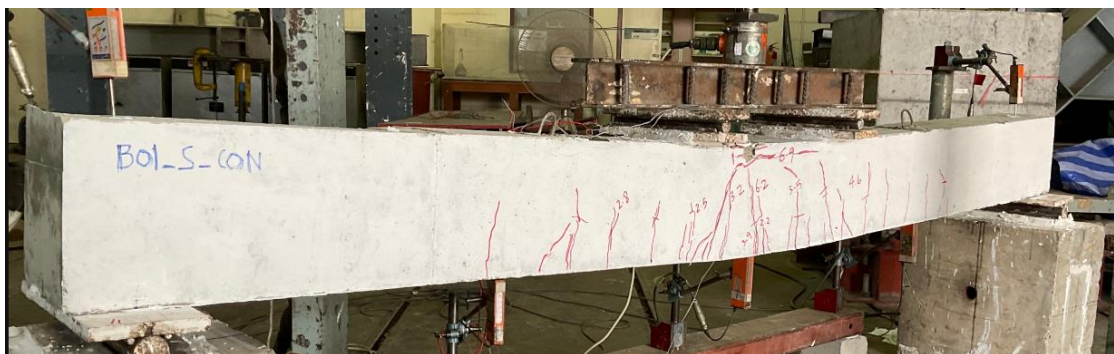
Figure 176 Failure mode of beam B01-SS-CON

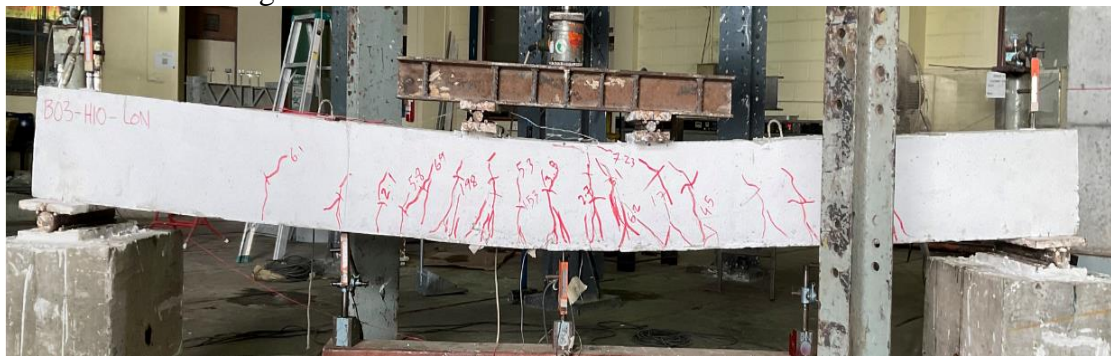
Figure 178 Failure mode of beam B03-HS100-CON

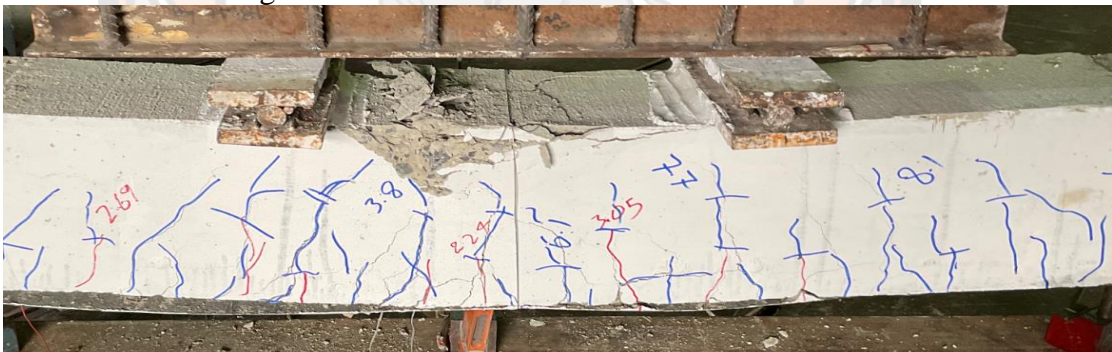
Figure 181 Excessive concrete crushing observed in beam B06-HS100-SCA

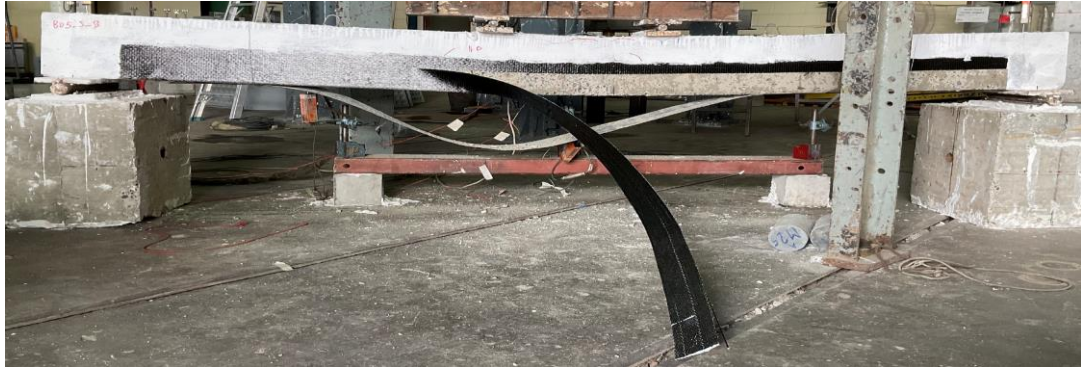
Figure 182 Typical CFRP rupture observed in 3rd group
